**Flood Control Project Maintenance
Levee Inspections**

Fall 2018 Levee Maintenance Deficiency Summary Report

San Joaquin River Basin

Reclamation District No. 2058 Pescadero

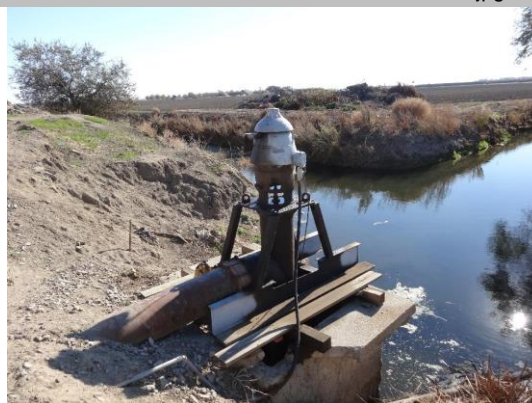
Photo 1 of 3 : UCIP_FA_2018_45843_45165.jpg

Comment Code						
Inspector Comment						
FS_ID:45843 DS_ID:22700 EP_NO: 5055 Repair Type: Non-Urgent Crossing Status: Found UCIP Comments: Excessive oil leakage. FIELD_STRUCT_DESC: 16-inch steel drainage discharge pipe through the levee, 3.8 feet below the crown. Drainage ditch on the landside (LS). Pump on a concrete sump on the LS. Siphon breaker under protective cover on the waterside (WS) slope. (To abandon the existing 12-inch pipe with concrete and install a new 16-inch pipe authorized under Permit No. 5055, 1965 - Stanley Electric Motor Company). 12-inch pipe grouted in place. [Additional Reference(s): DWR Levee Log, 2005. USACE San Joaquin O&M Manual 10, March 1964, (HLM 0.72)]. FS Date: 5/12/2015

LS view: exposed pipe and vertical pump on concrete sump on drain ditch.

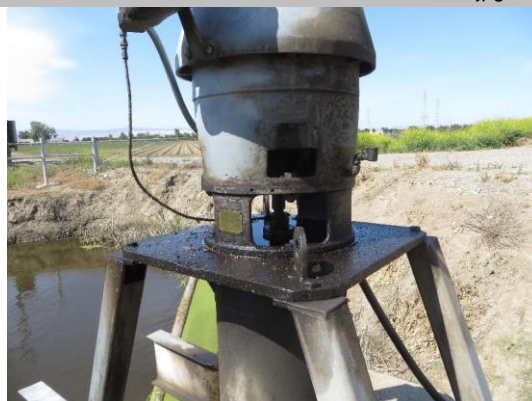
Photo 2 of 3 : UCIP_FA_2018_45843_74061.jpg

Comment Code						
Inspector Comment						
FS_ID:45843						
DS_ID:22700						
EP_NO: 5055						
Repair Type: Non-Urgent						
Crossing Status: Found						
UCIP Comments: Excessive oil leakage.						
FIELD_STRUCT_DESC: 16-inch steel drainage discharge pipe through the levee, 3.8 feet below the crown. Drainage ditch on the landside (LS). Pump on a concrete sump on the LS. Siphon breaker under protective cover on the waterside (WS) slope. (To abandon the existing 12-inch pipe with concrete and install a new 16-inch pipe authorized under Permit No. 5055, 1965 - Stanley Electric Motor Company). 12-inch pipe grouted in place. [Additional Reference(s): DWR Levee Log, 2005. USACE San Joaquin O&M Manual 10, March 1964, (HLM 0.72)].						
FS Date: 5/12/2015

LS view: closeup of pump showing excessive oil leakage.

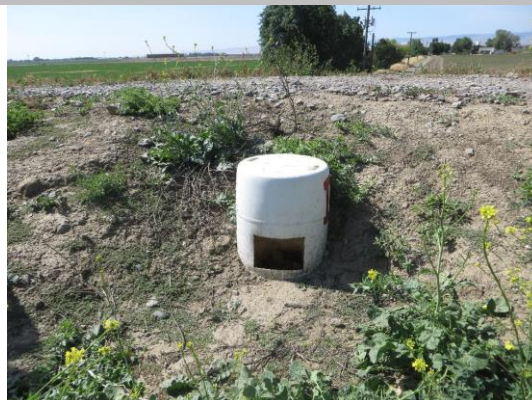
Photo 3 of 3 : UCIP_FA_2018_45843_74060.jpg

WS view: siphon breaker in protective casing.

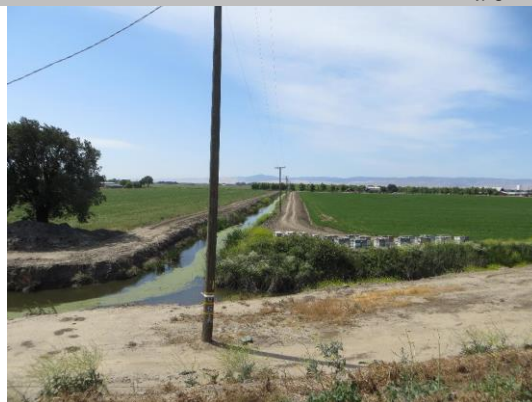
Photo 1 of 1 : UCIP_FA_2018_45847_74322.jpg

LM Start	1.21	Rating **	M	Issue No.	977
LM End	1.21	Issue Type +	En	Location *	
Category	Supplemental			GPS Latitude/Longitude	
				Start	End
Item	DWR UCIP Field Study			37.802249 °	37.802249 °
				-121.402183 °	-121.402183 °
DWR ID	22693				
Comment Code					
Inspector Comment					
FS_ID:45847					
DS_ID:22693					
EP_NO: 10426					
Repair Type: Non-Urgent					
Crossing Status: Indicator Found					
UCIP Comments: Crossing needs to be marked.					
FIELD_STRUCT_DESC: 33-inch concrete encased steel sewer line through the levee, 17 feet below the crown. Manholes visible along Delta Avenue, but no other indicators visible at the levee. (Sewer line authorized under Permit No. 10426, 1975 - City of Tracy, care of CDM, Inc.). [Additional Reference(s): DWR Levee Log, 2005].					
FS Date: 5/12/2015

View of LS. Alignment of Crossing to right of canal at dirt access road.

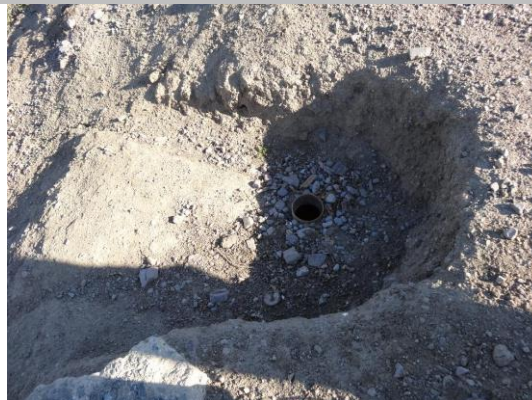
Photo 1 of 3 : UCIP_FA_2018_53374_45171.jpg

FS_ID:53374
DS_ID:22694
EP_NO: 11546
Repair Type: Urgent
Crossing Status: Found
UCIP Comments: 10/12/2018 Same as last inspection; keeping as Urgent due to erosion into levee prism (D. Sanoski - DWR UCIP). 11/29/2016 Heavy erosion still present. Could be due to wave run-up as this is the only spot on levee not rock revetted. Greg Pombo (RD2058) indicated permits for endangered species prevent rock revetment. (K. Fazel - UCIP) 05/12/2015 Erosion on west side of pipe at W/S toe. (K. Fazel - UCIP)
FIELD_STRUCT_DESC: 1 of 2: 18-inch steel drainage discharge pipe through the levee, 2 feet below the crown. Pump in drainage ditch on the landside (LS). Siphon breaker with cover on the waterside (WS) shoulder. Electrical service pole at the LS toe. (18-inch pipe and pump authorized under Permit No. 11546, 1976 - Reclamation District No. 2058). [Additional Reference(s): DWR Levee Log, 2005].
FS Date: 10/12/2018 9:59:00 AM

WS view: siphon breaker hole. Siphon breaker removed for repair.

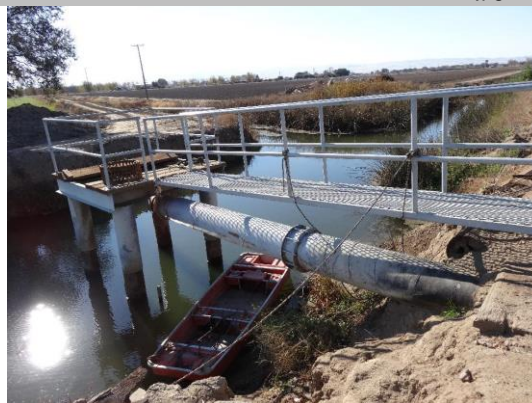
Photo 2 of 3 : UCIP_FA_2018_53374_45170.jpg

LS view: pipe, pile structure, and pump platform in drain ditch.

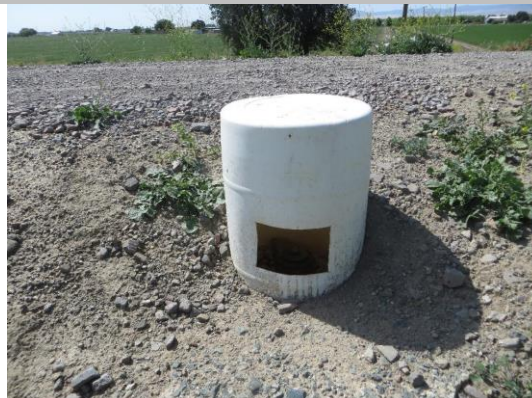
Photo 3 of 3 : UCIP_FA_2018_53374_74320.jpg

Comment Code						
Inspector Comment						
FS_ID:53374 DS_ID:22694 EP_NO: 11546 Repair Type: Urgent Crossing Status: Found UCIP Comments: 10/12/2018 Same as last inspection; keeping as Urgent due to erosion into levee prism (D. Sanoski - DWR UCIP).11/29/2016 Heavy erosion still present. Could be due to wave run-up as this is the only spot on levee not rock revetted. Greg Pombo (RD2058) indicated permits for endangered species prevent rock revetment. (K. Fazel - UCIP)05/12/2015 Erosion on west side of pipe at W/S toe. (K. Fazel - UCIP) FIELD_STRUCT_DESC: 1 of 2: 18-inch steel drainage discharge pipe through the levee, 2 feet below the crown. Pump in drainage ditch on the landside (LS). Siphon breaker with cover on the waterside (WS) shoulder. Electrical service pole at the LS toe. (18-inch pipe and pump authorized under Permit No. 11546, 1976 - Reclamation District No. 2058). [Additional Reference(s): DWR Levee Log, 2005]. FS Date: 10/12/2018 9:59:00 AM

Siphon Breaker on WS shoulder.

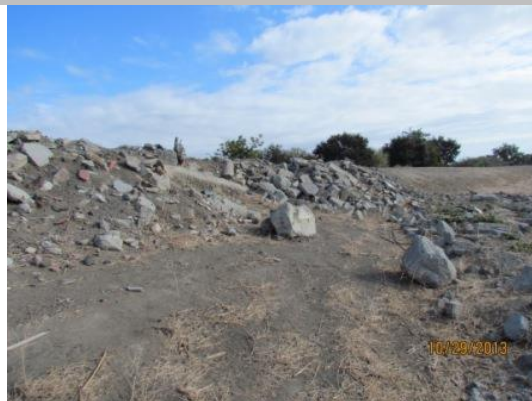
Photo 1 of 1 : FA_2018_RD2058_111_11_20180906_00006.jpg

LM Start	1.82	Rating **	U	Issue No.	11
LM End	1.83	Issue Type +	Ma	Location *	LS
Category	Earthen Levee			GPS Latitude/Longitude	
				Start	End
Item	Encroachments			37.804785 °	37.804802 °
				-121.391524 °	-121.391304 °
DWR ID	DWR_RD2058_01_f_2013_11				
Comment Code					
MA : Material					
Inspector Comment					
Pile of concrete contains rebar on landside slope obstructing visibility and access.

View of the concrete with rebar placed on the landside slope.

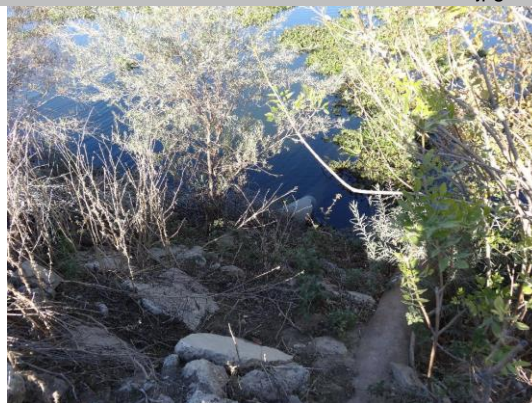
Photo 2 of 3 : UCIP_FA_2018_45865_74324.jpg

Pipe just visible at WS toe at center of photograph.

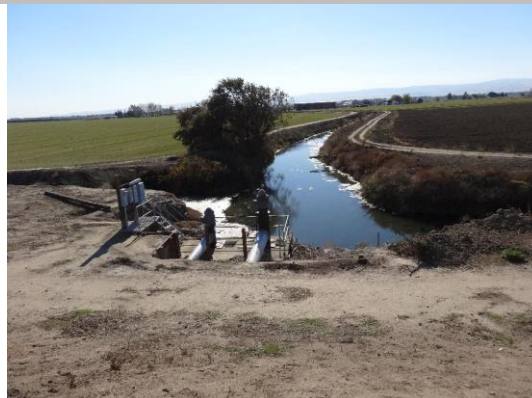
Photo 3 of 3 : UCIP_FA_2018_45865_74325.jpg

Pump on concrete pad at LS toe.

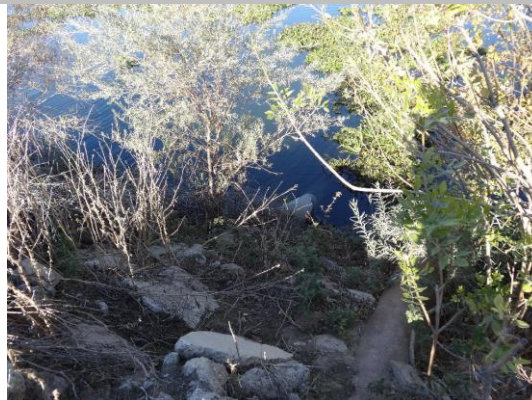
Photo 1 of 3 : UCIP_FA_2018_51699_45192.jpg

LM Start	2.12	Rating **	M	Issue No.	980	
LM End	2.12	Issue Type +	Ma	Location *		
Category	Supplemental			GPS Latitude/Longitude		
				Start		End
Item	DWR UCIP LMA Responsibility			37.803886 °		37.803886 °
				-121.386271 °		-121.386271 °
DWR ID	22706					
Comment Code						
Inspector Comment						
FS_ID:51699 DS_ID:22706 EP_NO: N/A Repair Type: Non-Urgent Crossing Status: Found UCIP Comments: Leaky and damaged siphon breaker on waterside shoulder.. FIELD_STRUCT_DESC: 16-inch steel drainage discharge pipe through the levee, 8 feet below the crown. Pump on a concrete sump in a drainage ditch on the landside (LS) toe. Siphon breaker on the waterside (WS) shoulder. [Additional Reference(s): USACE San Joaquin O&M Manual 10, March 1964, (HLM 2.14), 12-inch pipe referenced]. FS Date: 5/13/2015

WS view: exposed steel pipe (right) on channel bank.

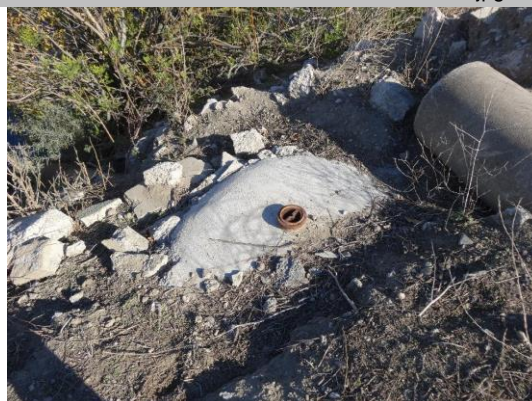
Photo 2 of 3 : UCIP_FA_2018_51699_45191.jpg

WS view: siphon breaker on concrete pad on levee slope.

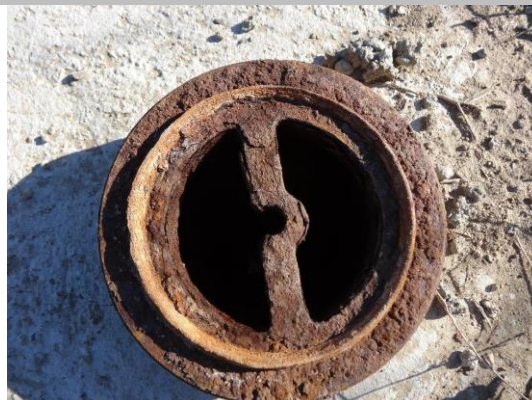
Photo 3 of 3 : UCIP_FA_2018_51699_45190.jpg

WS view: Upper part of the siphon breaker missing.

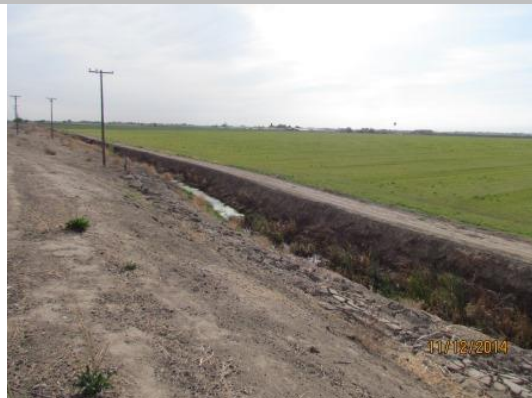
Photo 1 of 1 : FA_2018_RD2058_111_12_20180906_00007.jpg

View of the ditch at the landside levee toe.

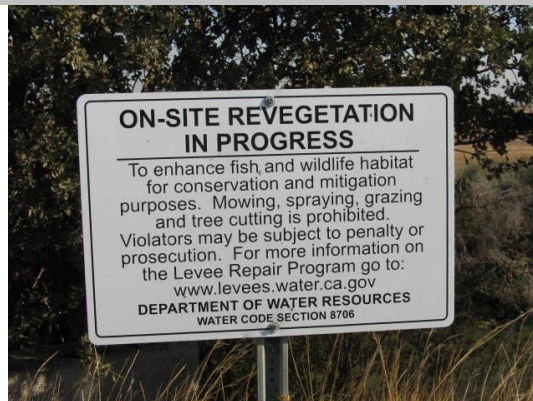
Photo 1 of 1 : FA_2018_RD2058_111_20_20180906_00012.jpg

11/08/2011 Revegetation site, cannot trim or cut vegetation in this area.

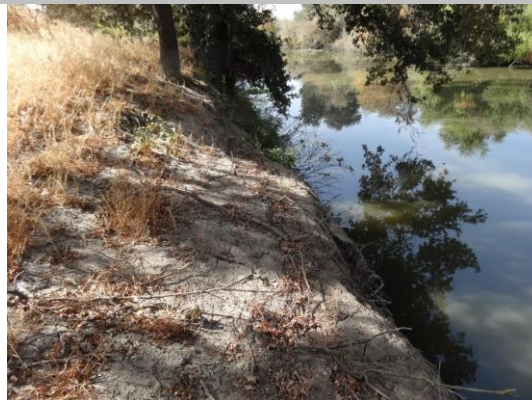
Photo 1 of 4 : FA_2018_RD2058_111_1_20180906_00001.jpg

Comment Code					
Inspector Comment					
10/10/2017: No significant change observed.					
07/20/2016: No significant change observed.					
08/04/2015: No significant change observed.					
08/26/2014: No significant change observed.					
08/28/2013: No significant change observed.					
07/26/2012: The site has been visited, and no significant change has been observed.					
09/02/2011: This site was not visited due to the time limit.					
09/22/2010: No significant change observed. Minor pocket erosions are lined at the lower bank. Two large Oak and Willow trees are on mid-slope and bench. The remaining bench was re-measured and found to be approximately 10 feet. There was no indication of active erosion on site during the site visit.					
08/05/2010: Recommended for annual assessment and monitoring of the site during flood events, per CLRO.					
07/23/2009: No major change observed since last visit; site is a 200-ft. long near-vertical berm erosion; recommend annual assessment and monitoring of the erosion site, per CLRO CES Evaluation 2008 Report; Site # is the same site previously reported as RM4.0,LM4.51; previously rated "U".

Direct view of the pocket erosion site.

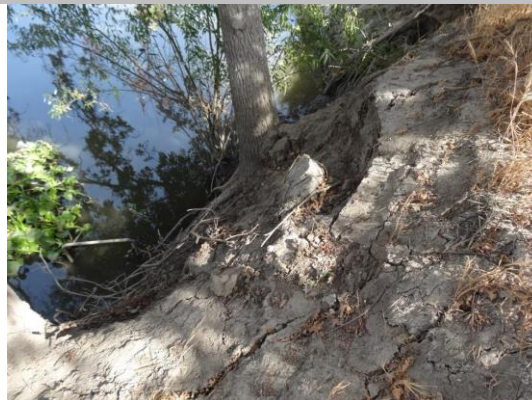
Photo 2 of 4 : FA_2018_RD2058_111_1_20180906_00002.jpg

Direct view of the erosion near a tree.

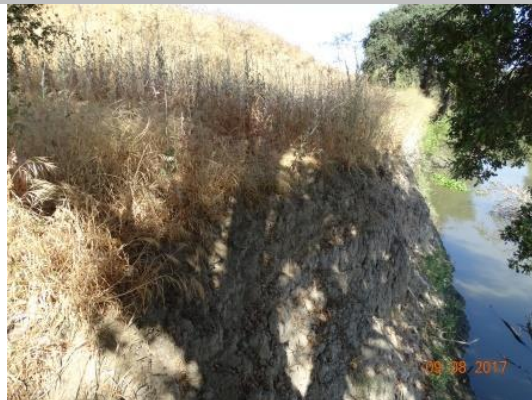
Photo 2 of 5 : FA_2018_RD2058_111_40_20180906_00022.jpg

LM Start	4.63	Rating **	A/W	Issue No.	40 (cont)	
LM End	4.76	Issue Type +	Ma	Location *	WS	
Category	Earthen Levee			GPS Latitude/Longitude		
				Start		End
Item	Erosion / Bank Caving			37.787756 °	37.785971 °	
				-121.350851 °	-121.350372 °	
DWR ID	DWR_RD2058_01_f_2017_40					
Comment Code						
E2 : Schedule repair of erosion site prior to the next inspection.						
Inspector Comment						
Erosion on the waterside is greater than three feet tall into the levee prism.

Another downstream view of the erosion.

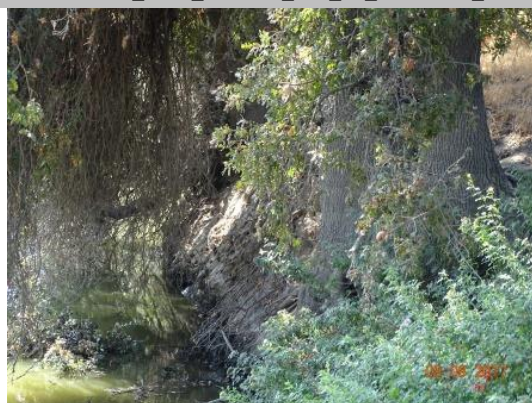
Photo 3 of 5 : FA_2018_RD2058_111_40_20180906_00023.jpg

Upstream view of the erosion site.

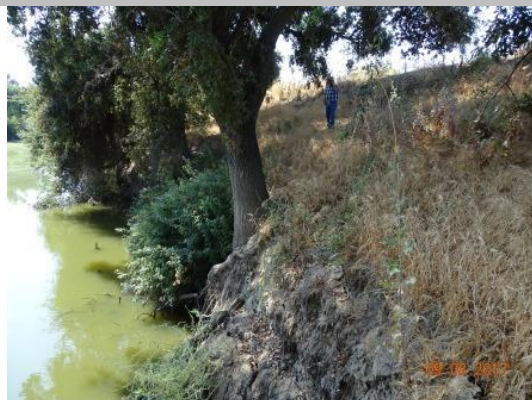
Photo 4 of 5 : FA_2018_RD2058_111_40_20180906_00024.jpg

Another upstream view of the erosion site.

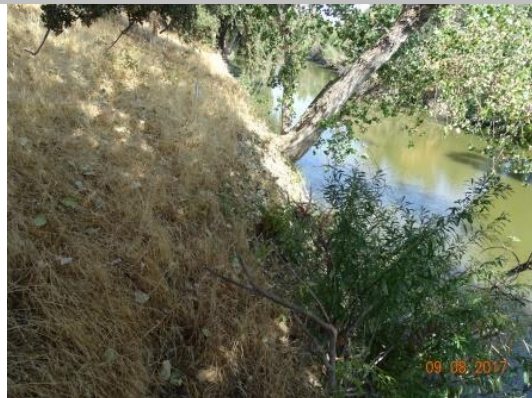
Photo 3 of 3 : FA_2018_RD2058_111_15_20180906_00010.jpg

Downstream view of the erosion site.

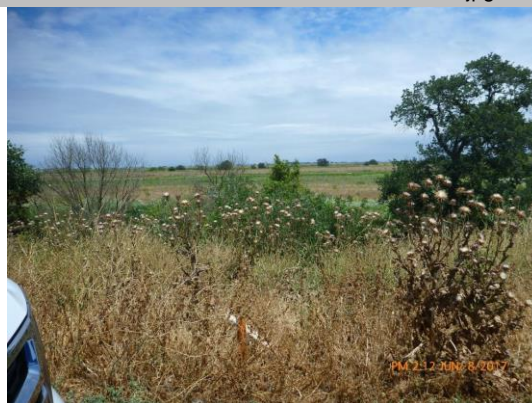
LM Start	4.77	Rating **	A/W	Issue No.	44
LM End		Issue Type +	Ma	Location *	
Category	Supplemental			GPS Latitude/Longitude	
				Start	End
Item	2017 Storm Damage			37.785862 °	°
				-121.350303 °	°
DWR ID	DWR_RD2058_01_f_2017_44				
Comment Code					
Inspector Comment					
Levee Evaluation Comments					
Description:					
Site ID No:100					
Site Designation:FSRP-14-25					
Repair Type: Erosion					
Rating:Area of Concern					
Field Date:6/8/2017					
Notes: vegetation too dense to evaluate damage. The erosion has about a 3 foot vertical cut at the waterside levee toe as of the Fall 2017 Inspection. Turned back over to Evaluators for re-assessment.

LM Start	4.77	Rating **	A/W	Issue No.	44 (cont)	
LM End		Issue Type +	Ma	Location *		
Category	Supplemental			GPS Latitude/Longitude		
				Start	End	
Item	2017 Storm Damage			37.785862 °		
				-121.350303 °		
DWR ID	DWR_RD2058_01_f_2017_44					
Comment Code						
Inspector Comment						
Levee Evaluation Comments						
Description:						
Site ID No:100						
Site Designation:FSRP-14-25						
Repair Type: Erosion						
Rating:Area of Concern						
Field Date:6/8/2017						
Notes: vegetation too dense to evaluate damage. The erosion has about a 3 foot vertical cut at the waterside levee toe as of the Fall 2017 Inspection. Turned back over to Evaluators for re-assessment.

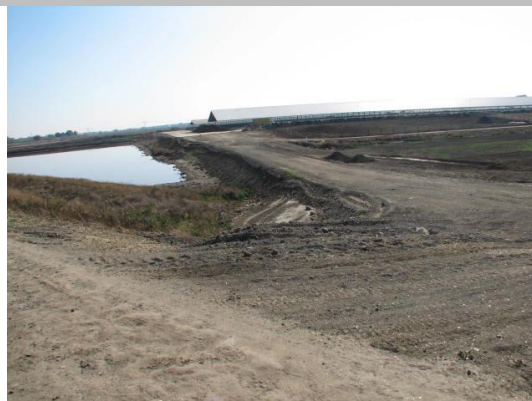
Photo 3 of 3 : FA_2018_RD2058_111_29_20180906_00017.jpg

11/08/2011 New ramp has been constructed by Dairy farmer connecting his barns to the levee.

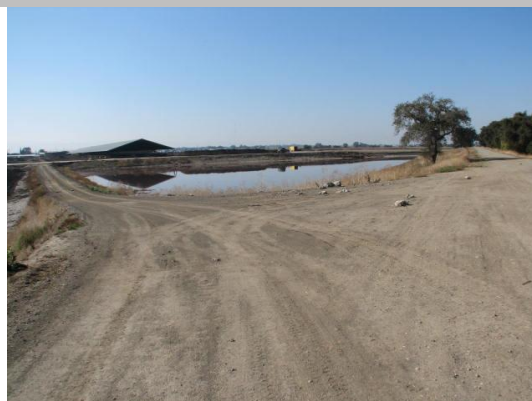
Photo 1 of 3 : FA_2018_RD2058_111_30_20180906_00018.jpg

11/08/2011 Photo shows existing middle ramp to the levee which has been raised.

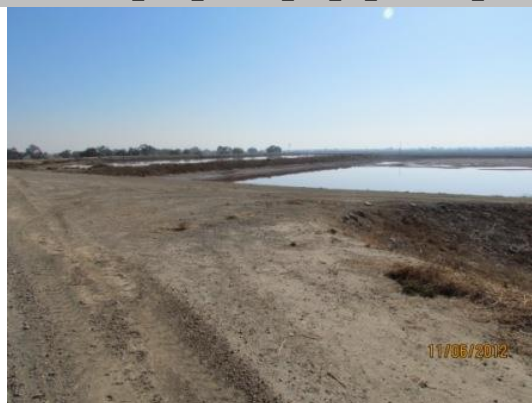
Photo 2 of 3 : FA_2018_RD2058_111_30_20180906_00019.jpg

Completed new ramp constructed by Dairy farmer connecting his barns to the levee.

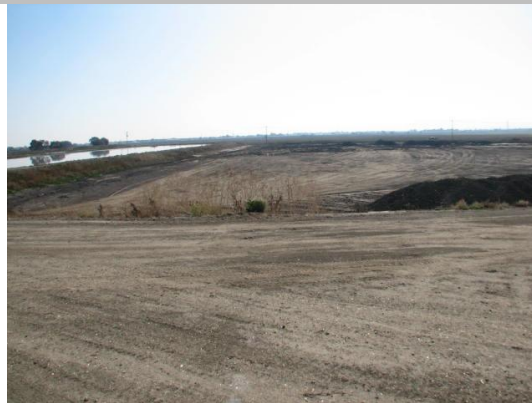
Photo 3 of 3 : FA_2018_RD2058_111_30_20180906_00020.jpg

11/08/2011 Photo shows view from the levee looking to the left of the middle ramp.

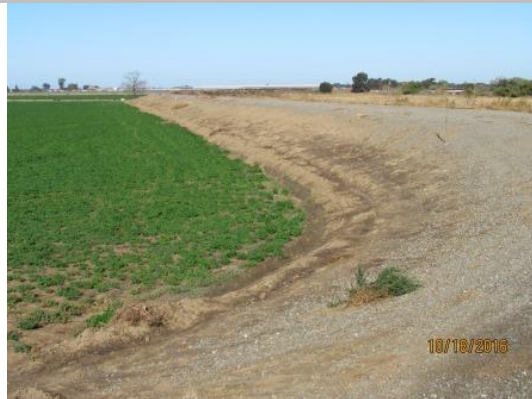
Photo 1 of 1 : FA_2018_RD2058_111_19_20180906_00011.jpg

View of the ditch at the landside levee toe.

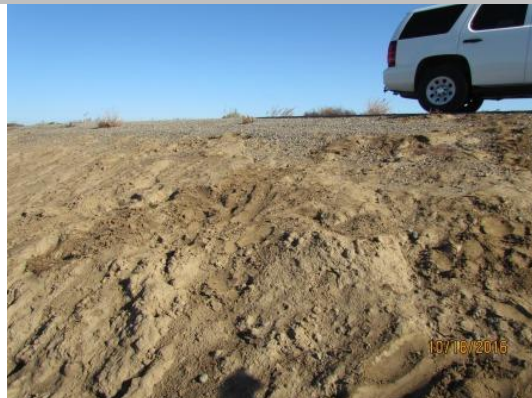
Photo 1 of 1 : FA_2018_RD2058_111_28_20180906_00014.jpg

View of the rodent holes on the levee slope.

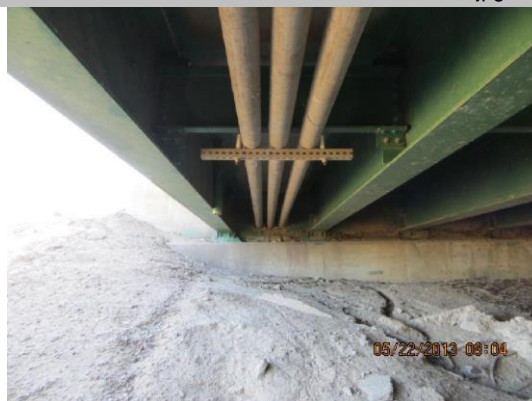
Photo 1 of 3 : UCIP_FA_2018_45871_73100.jpg

Comment Code						
Inspector Comment						
FS_ID:45871						
DS_ID:22701						
EP_NO: 13262						
Repair Type: Non-Urgent						
Crossing Status: Indicator Found						
UCIP Comments: Owner needs to install signs at crossing.						
FIELD_STRUCT_DESC: 1 of 3: 4-inch concrete encased polyvinyl chloride (PVC) electrical conduit through the levee, 3 feet below the crown. Signs on both banks of the levee. Manholes on both sides of Manthey Road. Pipes visible under Manthey Road bridge. (To install three 4-inch concrete encased PVC electrical conduits through the levee authorized under Permit No. 13262, 1981 - Pacific Telephone and Telegraph Company [PT&T]).						
FS Date: 5/13/2015

Pipes visible under Manthey Rd Bridge at Paradise Cut.

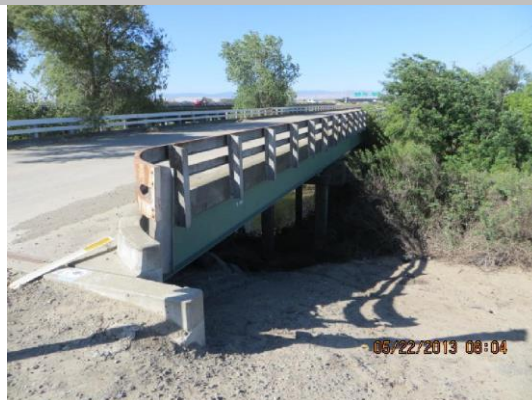
Photo 2 of 3 : UCIP_FA_2018_45871_73101.jpg

Pipes visible under Manthey Rd Bridge at Paradise Cut.

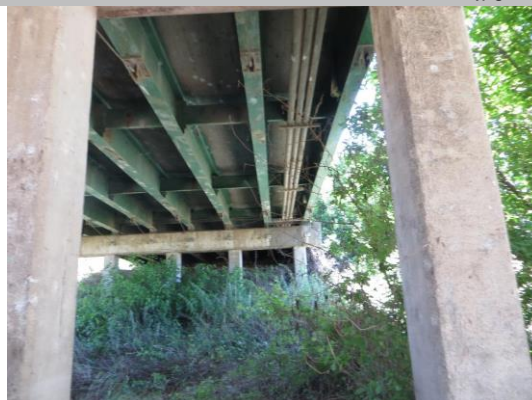
Photo 1 of 3 : UCIP_FA_2018_45768_74267.jpg

Pipes visible under Manthey Rd Bridge at Paradise Cut

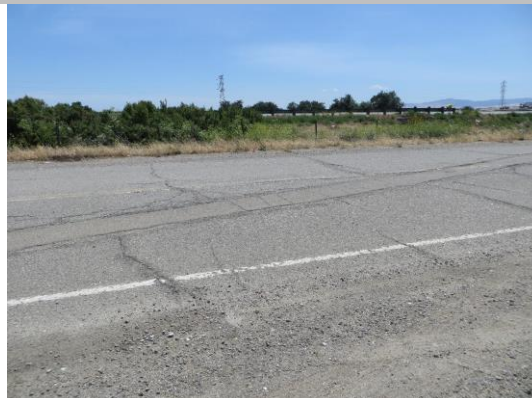
Photo 2 of 3 : UCIP_FA_2018_45768_74268.jpg

Cuts in pavement visible appr. 450 ft from WS toe.

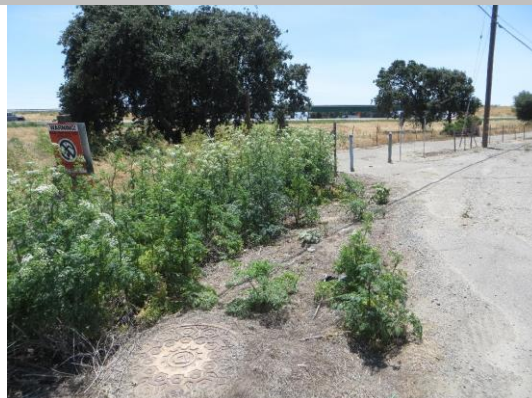
Photo 3 of 3 : UCIP_FA_2018_45768_74269.jpg

Comm sign and Pac Bell manhole appr. 600 ft from LS toe.

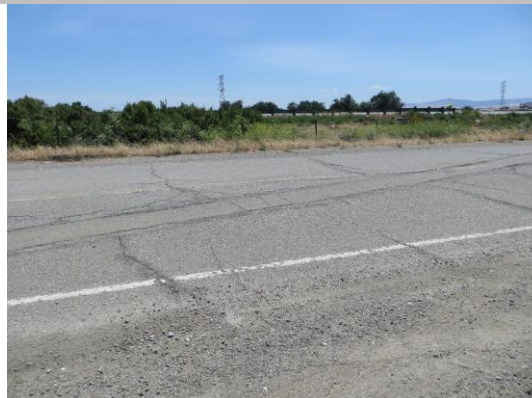
Photo 1 of 3 : UCIP_FA_2018_45769_74270.jpg

Cuts in pavement visible appr. 450 ft from WS toe.

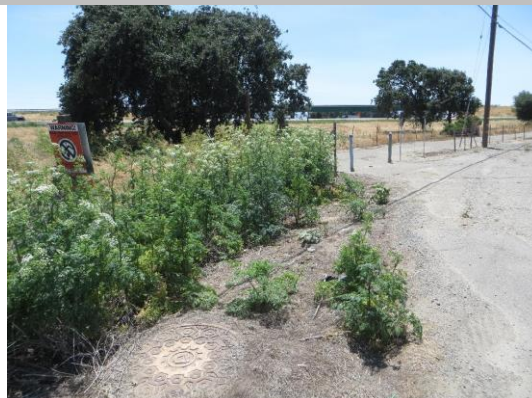
Photo 2 of 3 : UCIP_FA_2018_45769_74271.jpg

Comm sign and Pac Bell manhole appr. 600 ft from LS toe.
